**Test Report**

No.: NGBPC26004275601

Sample Name: CPP(FPP)

**EU RoHS Directive (EU) 2015/863 amending Annex II to Directive 2011/65/EU - Lead, Mercury, Cadmium, Hexavalent chromium, Polybrominated biphenyls (PBB), Polybrominated diphenyl ethers (PBDE), Bis(2-ethylhexyl) phthalate (DEHP), Butyl benzyl phthalate (BBP), Dibutyl phthalate (DBP) and Diisobutyl phthalate (DIBP)**

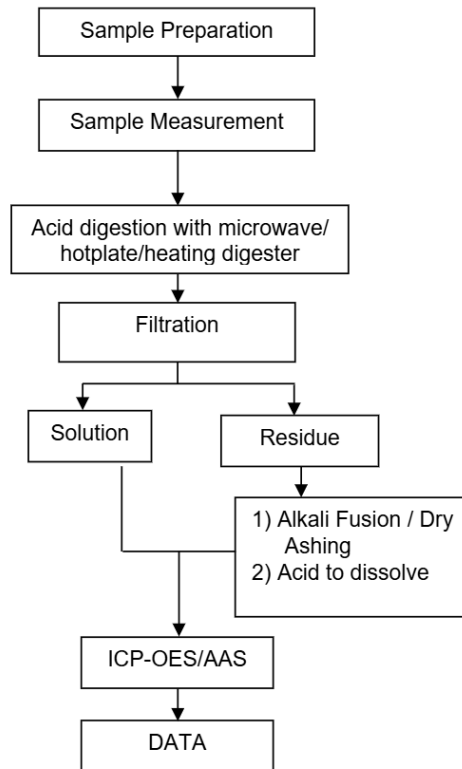
**Elements Testing Flow Chart**

These samples of Pb/Cd/Hg were dissolved totally by pre-conditioning method according to below flow chart.

**Test Method:** With reference to IEC 62321-4:2013+AMD1:2017, IEC 62321-5:2013, IEC 62321-7-2:2017, IEC 62321-6:2015 and IEC 62321-8:2017, analysis was performed by ICP-OES/AAS, UV-Vis and GC-MS.

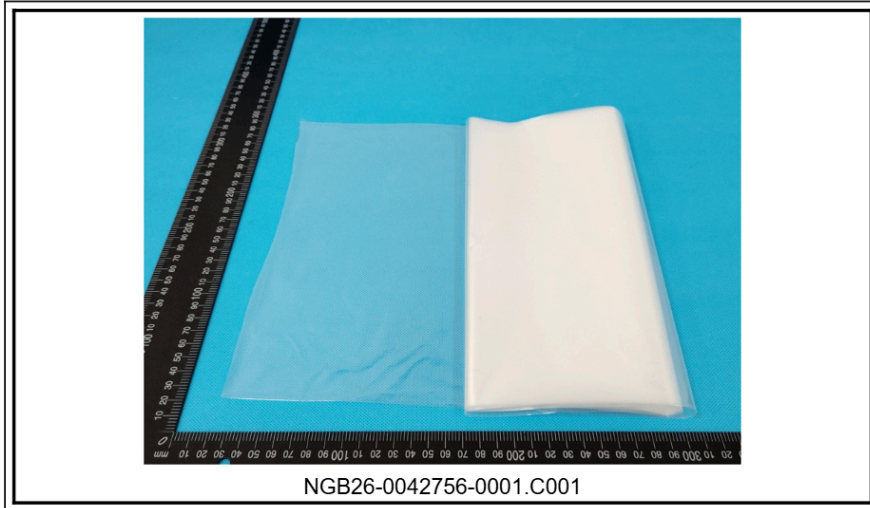
**Sample Photo:**

SN ID	Sample No.	SGS Sample ID	Description
SN1	001	NGB26-0042756-0001.C001	TRANSPARENT SOFT SOLID FILM
